2. **AUTHORISED RELEASE CERTIFICATE
EASA FORM 1**

6. Item	7. Description	8. Part No.	9. Qty.	10. Serial No.	11. Status/Work
1	NOSE COWL, FULLY EQUIPPED	SJ30361	ONE	SB/RR/TT700/1391	INSPECTED /TESTED

SERVICE BULLETIN RB211-NAC-71-018

Non Destructive Inspection Report for Bombardier Aerospace - Shorts

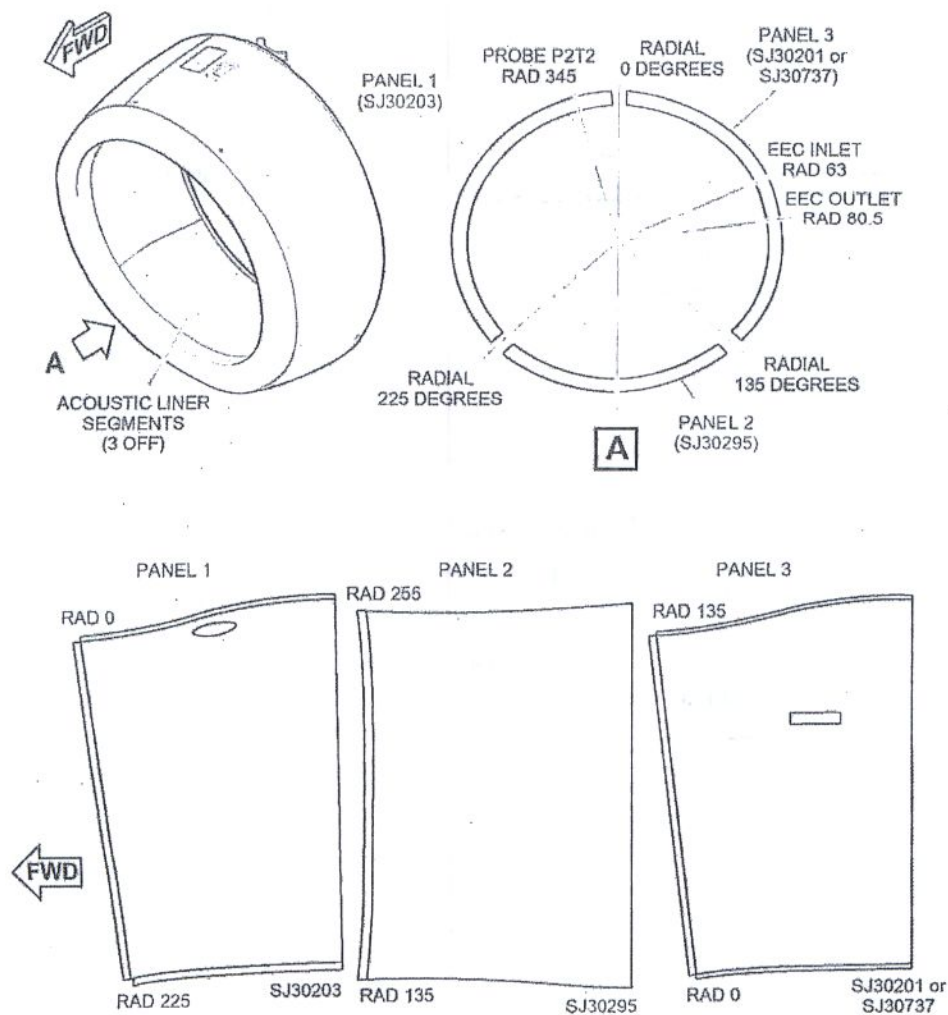
Figure 2 (TAP TEST INSPECTION – RESULTS)

100% TAP TEST OF ALL AIR INTAKE COWL PANELS, BETWEEN THE ACOUSTIC LINING AND NOMEX HONEYCOMB CORE, TO INSPECT FOR AREAS OF DISBOND.

(RECORD LOCATION & SIZE OF DISBONDS ON DIAGRAM 1)

• REPEAT INSPECTION REQUIRED AFTER 50 CYCLES AS PER RB211-NAC-71-018. REFER TO APPENDIX B FOR DETAILS.
