Borescope Inspection Report

**331-350C
SN: R-537C**

Borescope Inspection Report
331-350C
S/N:R-537C
Date: 11/01/2021

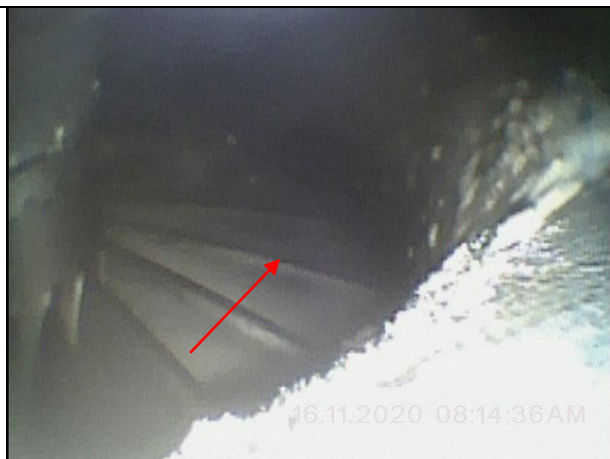
Picture 1: 1st Stage Engine Compressor Impeller

- 3.1 1st Stage Compressor Impeller: There is no damage visible on the impeller (Picture 1).

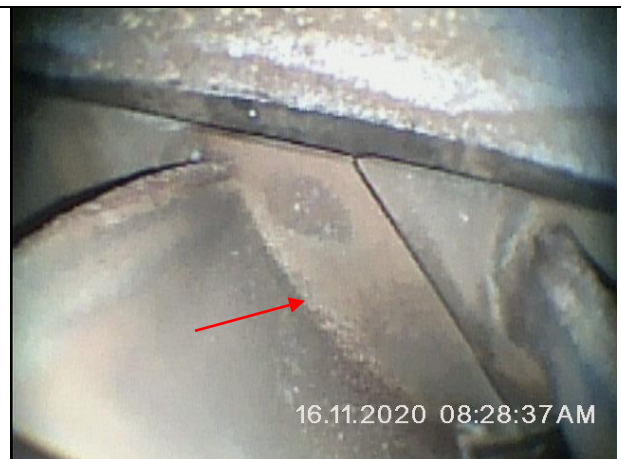
Picture 2: 1st Stage Turbine Stator Vanes

- 4.1 1st Stage Turbine Stator: There are no signs of damage on the stator vanes (Picture 2).
- 4.2 1st Stage Turbine Rotor: The turbine blades show no signs of damage (Picture 3).
- 4.3 3rd Stage Turbine Rotor: There is no evidence of damage to the turbine blades (Picture 4).
- 4.4 Combustion Chamber: There is no visible damage in the combustion chamber (Picture 5).

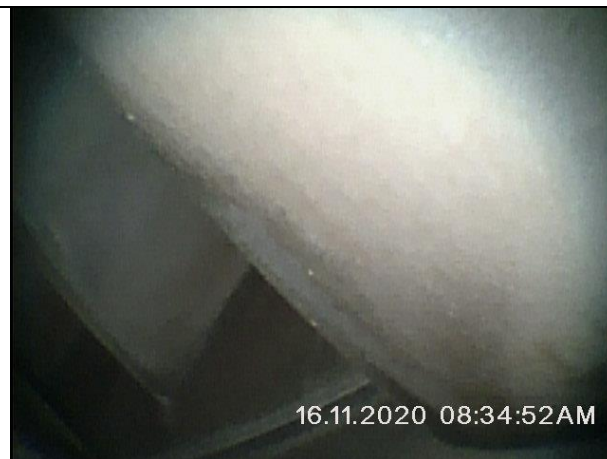
Picture 6: Load Compressor Impeller

5.1 Load Compressor Impeller: The impeller shows no signs of damage (Picture 6).
