AUTHORIZED RELEASE CERTIFICATE

FAA Form 8130-3, AIRWORTHINESS APPROVAL TAG

1 FWD FAN COWL LEFT ASSY

Inspection & Disposition**QA 110**

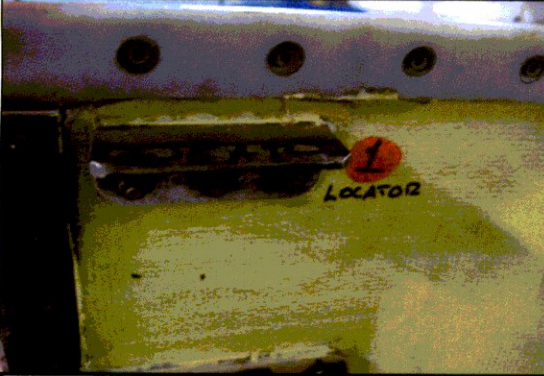
Disposition 1

**Discrepancy: WEAR**

FAN COWL ALL 3 LOCATORS HAVE WEAR PBEYOND LIMITS AS FOLLOWS UPPER .085", MIDDLE .059", LOWER .085.

Disposition: Remove/Replace

CACTUS WIRE GENERATED TO CREATE REPAIR TO WELD REPAIR LOCATORS TO ORIGINAL DIMENSIONS.

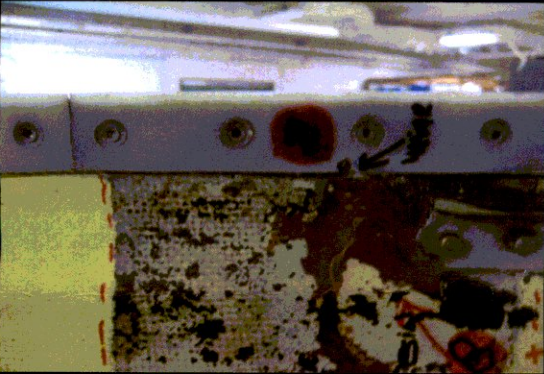
Disposition 2

**Discrepancy: WEAR**

THE LOWER EDGE PROTECTION SEGMENT HAS WEAR AT THE UPPER END. MEASURES .770"L X .275"W. AS WELL HAS A FOREIGN COATING UNDERNEATH OF IT.

Disposition: Remove/Replace

Remove/Replace per CMM 71-13-10, Disassembly Section 7.

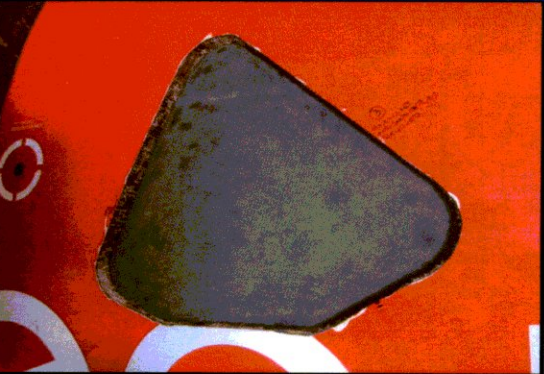
Disposition 3

**Discrepancy: CORE REMOVED**

THE FAN COWL WAS RECEIVED IN SHOP WITH THE AIR-WETTED SKIN AND THE CORE REMOVED, ONLY THE NON-WETTED SKIN REMAINS INTACT, MEASURES APPROX 180 SQ IN (20X18/2). LOCATED AT 19" FROM UPPER EOP X 4.0" FROM FWD EOP.(ZONE D-6) EXT. SURFACE.

Disposition: Generate Cactus Wire

Exceeds Repair limits of CMM 71-13-10. More than 5.58in². Generate Cactus wire to create new EA to repair this area.

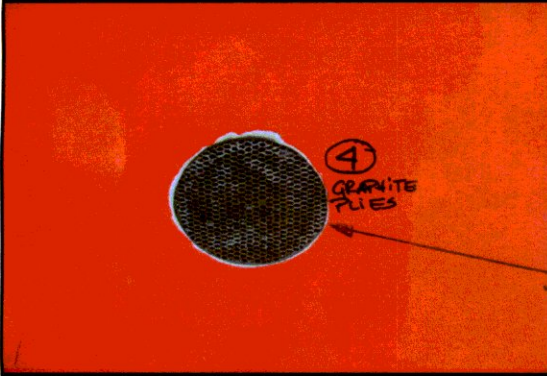
Disposition 4

**Discrepancy: EXPOSED CORE**

THE FAN COWL EXTERNAL SURFACE OF ZONE D-6 HAS AN AREA OF 3.200" OF CIRCUNFERENCE WITH THE HONEYCOMB CORE EXPOSED. LOCATED AT 48" FROM UPPER EOP X 11" FROM FWD EOP.

Disposition: Generate Cactus Wire

Exceeds Repair limits of CMM 71-13-10. More than 5.58in². Generate Cactus wire to create new EA to repair this area.

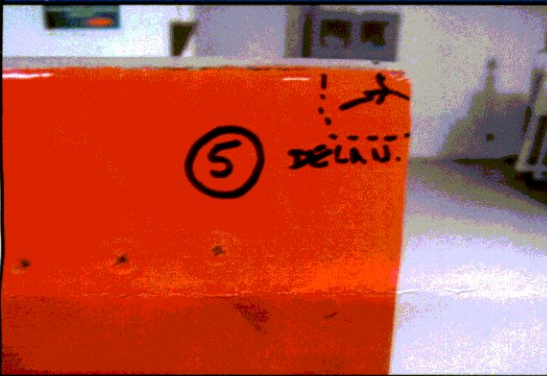
Disposition 5

**Discrepancy: DELAMINATION**

THE FAN COWL AT FWD-UPPER CORNER IS DELAMINATED MEASURES 1.350"L X .350"W. EXTERNAL SURFACE OF ZONE D-3.

Disposition: Repair Delamination

Repair Delamination per CMM 71-13-10, Repair 10.

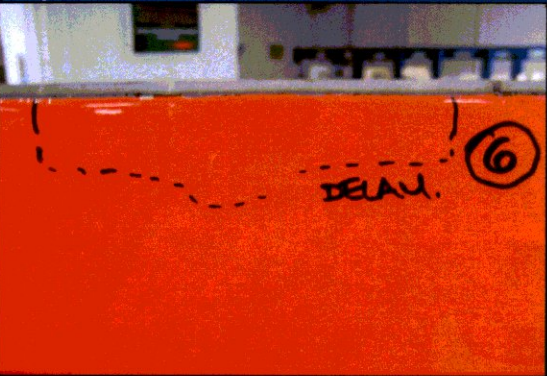
Disposition 6

**Discrepancy: DELAMINATED**

THE FAN COWL IS DELAMINATED, MEASURES 3.995"L X 1.070"W, LOCATED AT EXTERNAL SURFACE OF ZONE D-3 X 55" FROM UPPER EOP. POSSIBLE HIDDEN DAMAGE (CRACK) 1.0"L.

Disposition: Generate Cactus Wire

Exceeds Repair limits of CMM 71-13-10. More than 5.58in². Generate Cactus wire to create new EA to repair this area.

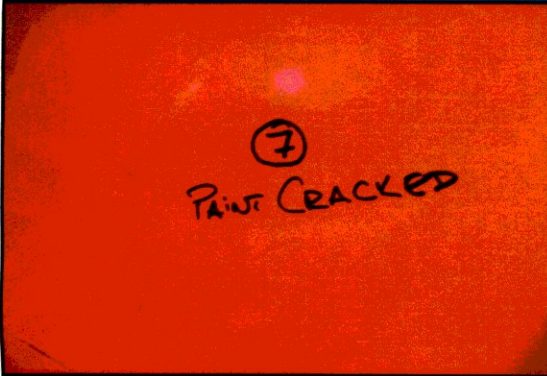
Disposition 7

**Discrepancy: PAINT CRACKING**

FAN COWL, THE EXTERNAL SURFACE HAS THE PAINT CRACKING.

Disposition: Customer Request

Remove and re-paint surface with BMS 10-11, BAC 702 White Gloss Paint.

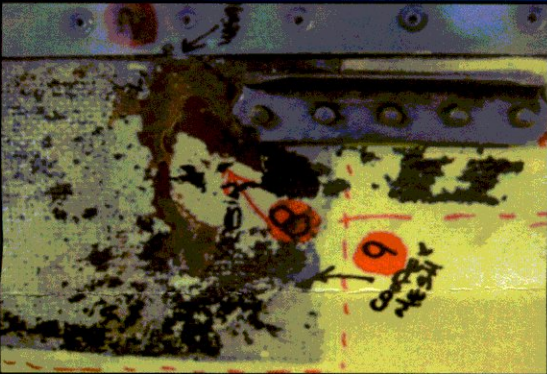
Disposition 8

**Discrepancy: EXCESSIVE COATING**

INTERNAL SURFACE AT ZONE D-3 WHERE THE EDGE PROTECTION SPLITS TOWARDS THE LOCATOR, HAS A PREVIOUS REPAIR WITH EXCESSIVE COATING. THE OUTER SURFACE IS DELAMINATED SEE DISC. #6.

Disposition: Refer to Disp. 9

Excessive coating exists in area of damaged copper mesh. This damage will be consumed in the repair of Discrepancy 9 per CMM 71-13-10, Repair 8.

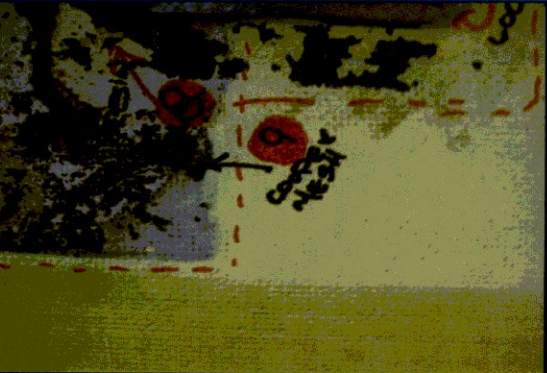
Disposition 9

**Discrepancy: ABRASION**

INNER SURFACE AROUND MIDDLE LOCATOR AREA BETWEEN ZONES D-2 AND D-3 HAS ABRASION, THE COPPER MESH IS DAMAGED MEASURES 5"L X 5"W, AS WELL THE PRIMER COATING ADJACENT TO THIS AREA IS PEELING OFF.

Disposition: Repair Copper Mesh

Repair Copper Mesh per CMM 71-13-10, Repair 8.

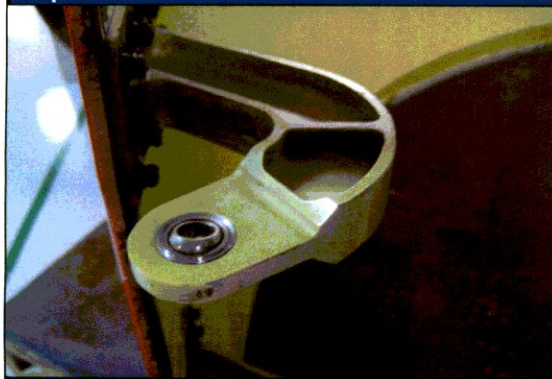
Disposition 10

**Discrepancy: FPI REQUIRED**

FPI TO THE GOOSENECK ASSY REQUIERD PER PW TRAVELLER
SUBJECT 4, ITEM 0040/2.

Disposition: Perform FPI

Perform local FPI per SPOP
