A J WALTERS DAMAGE REPORT

ENGINE TYPE: TRENT 700

UNIT TYPE: COMMON NOZZLE ASSEMBLY

Date: 15TH NOVEMBER 2023

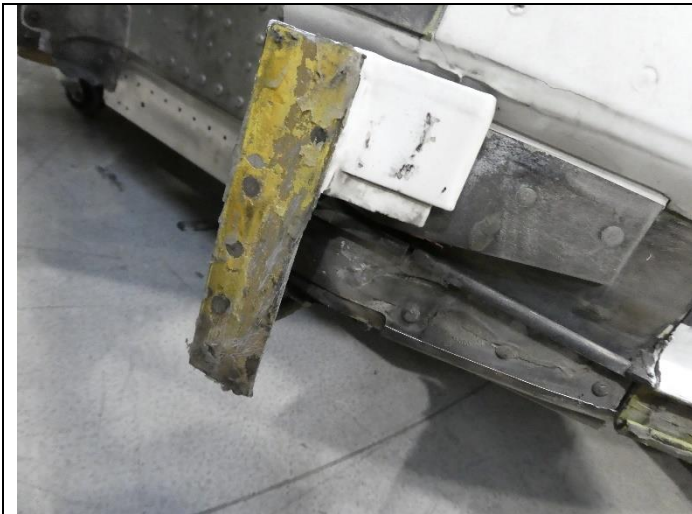
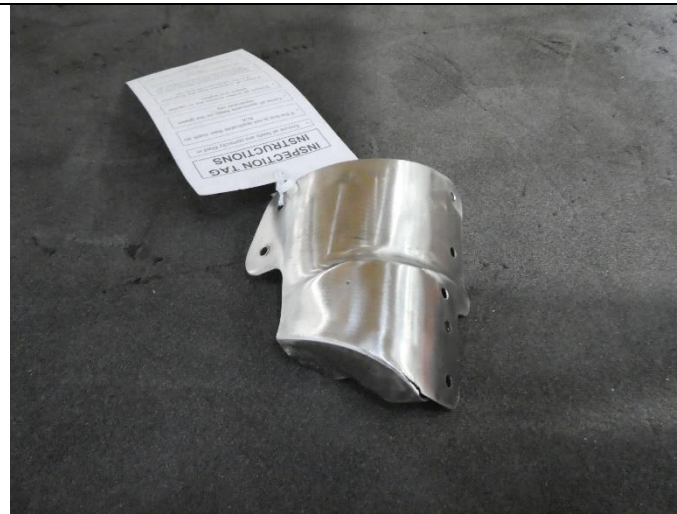
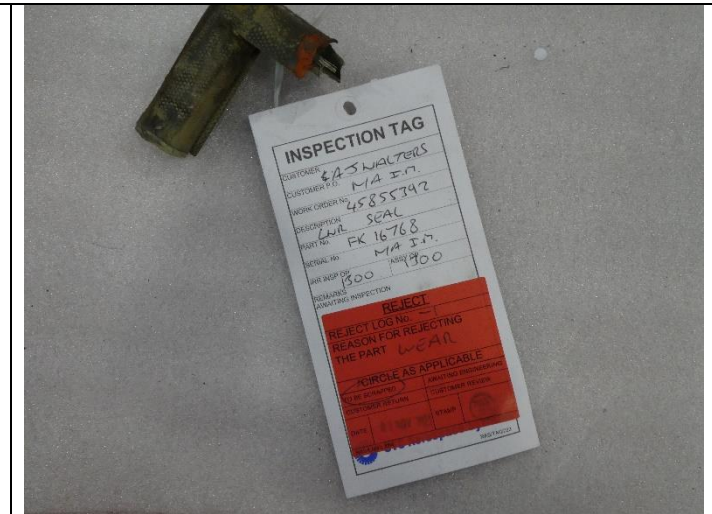
EXHIBIT No 1	EXHIBIT No 2	EXHIBIT No 3
<ul style="list-style-type: none"> Describe view: <u>top plate rubstrip (FK16657)</u> Extent of Damage: <u>worn</u> Dimensions of damage: <u>full landing face</u> Operation relating to the IRR: <u>1280</u> For further details see Exhibit #: <u>n/a</u> Repair proposal: <u>Replace rubstrip i.a.w CMM 78-11-14 repair 005.</u> 	<ul style="list-style-type: none"> Describe view: <u>LH blank assembly</u> Extent of Damage: <u>crack</u> Dimensions of damage: <u>0.5"</u> Operation relating to the IRR: <u>1291</u> For further details see Exhibit #: <u>n/a</u> Repair proposal: <u>Repair i.a.w. 276-1037-89-WDS-CRCK. (Weld repair)</u> 	<ul style="list-style-type: none"> Describe view: <u>lower seal assembly</u> Extent of Damage: <u>split</u> Dimensions of damage: <u>across various areas on part.</u> Operation relating to the IRR: <u>1300</u> For further details see Exhibit #: <u>n/a</u> Repair proposal: <u>Replace lower seal i.a.w. CMM 78-11-14 repair 001.</u>

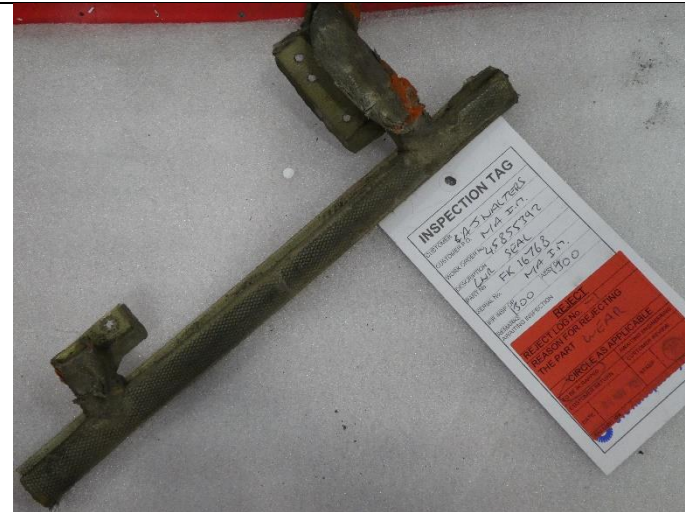
EXHIBIT No 4

- Describe view: lower seal assembly
- Extent of Damage: split
- Dimensions of damage: across various areas on part.
- Operation relating to the IRR: 1300
- For further details see Exhibit #: n/a
- Repair proposal: Replace lower seal i.a.w. CMM 78-11-14 repair 001.

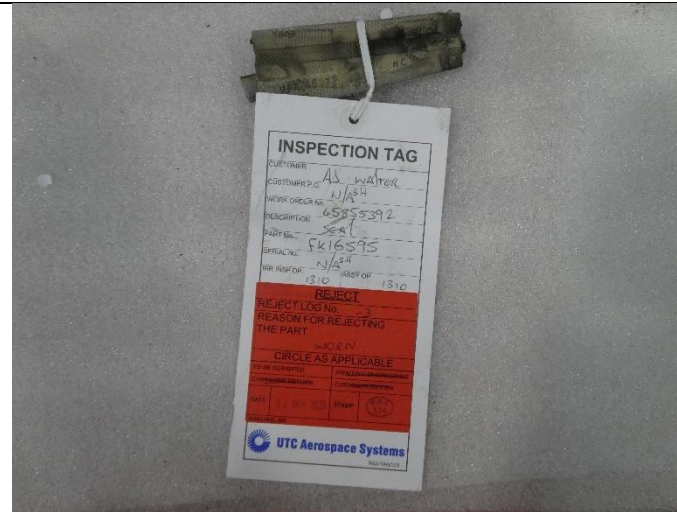
EXHIBIT No 5

- Describe view: outer duct seals
- Extent of Damage: worn
- Dimensions of damage: across full part
- Operation relating to the IRR: 1310
- For further details see Exhibit #: exhibit 6
- Repair proposal: Replace seal i.a.w CMM 78-11-14 Repair 001.

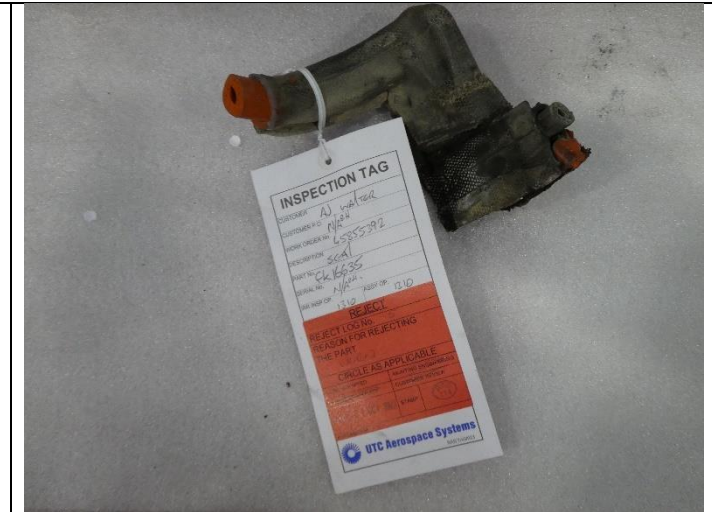
EXHIBIT No 6

- Describe view: outer duct seals
- Extent of Damage: worn
- Dimensions of damage: across full part
- Operation relating to the IRR: 1310
- For further details see Exhibit #: exhibit 7
- Repair proposal: Replace seal i.a.w CMM 78-11-14 Repair 001.

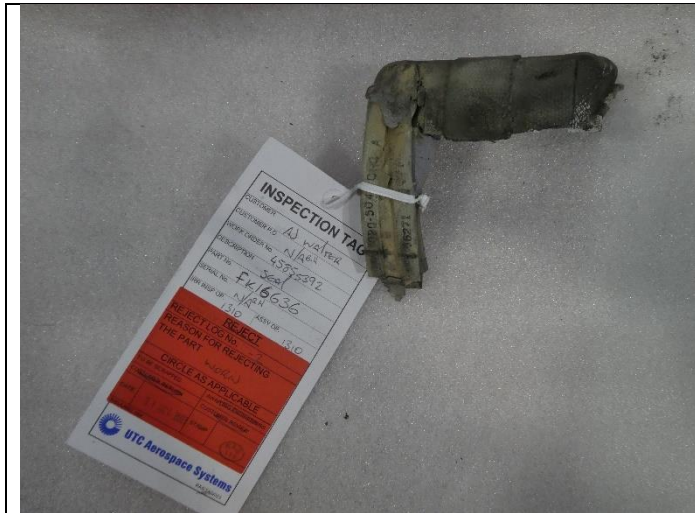
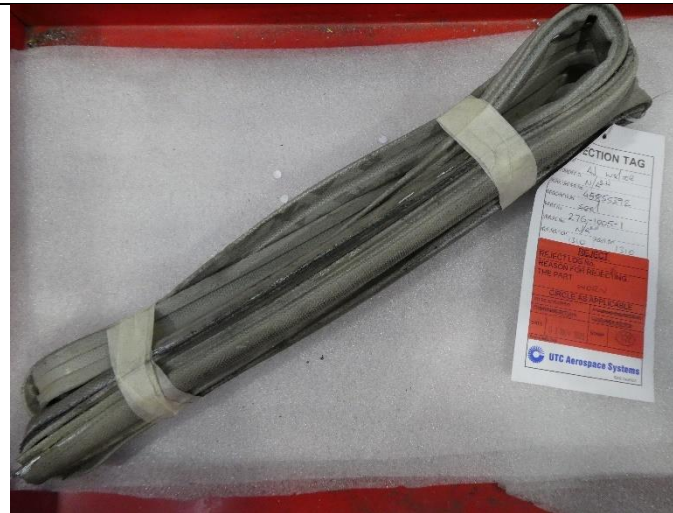
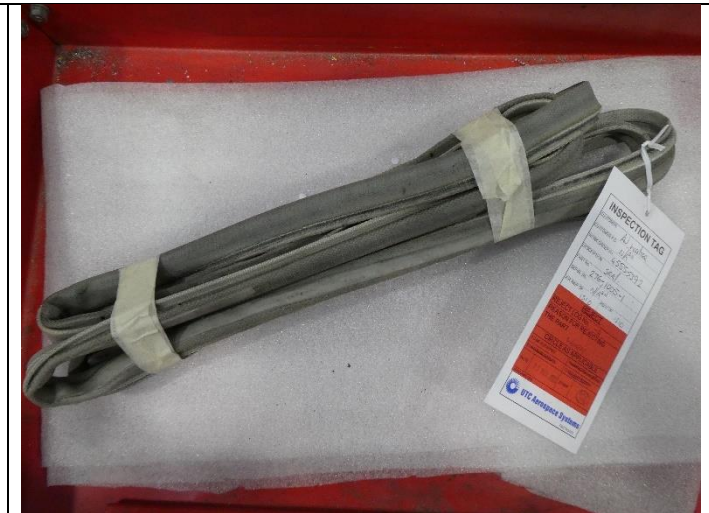
EXHIBIT No 7	EXHIBIT No 8	EXHIBIT No 9
<ul style="list-style-type: none"> Describe view: outer duct seals Extent of Damage: worn Dimensions of damage: across full part Operation relating to the IRR: 1310 For further details see Exhibit #: exhibit 8 Repair proposal: Replace seal i.a.w CMM 78-11-14 Repair 001. 	<ul style="list-style-type: none"> Describe view: outer duct seals Extent of Damage: worn Dimensions of damage: across full part Operation relating to the IRR: 1310 For further details see Exhibit #: exhibit 9 Repair proposal: Replace seal i.a.w CMM 78-11-14 Repair 001. 	<ul style="list-style-type: none"> Describe view: outer duct seals Extent of Damage: worn Dimensions of damage: across full part Operation relating to the IRR: 1310 For further details see Exhibit #: exhibit 10 Repair proposal: Replace seal i.a.w CMM 78-11-14 Repair 001.

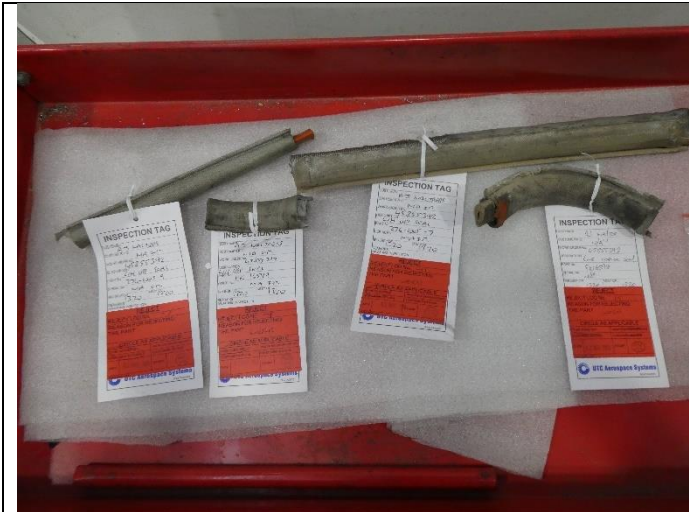
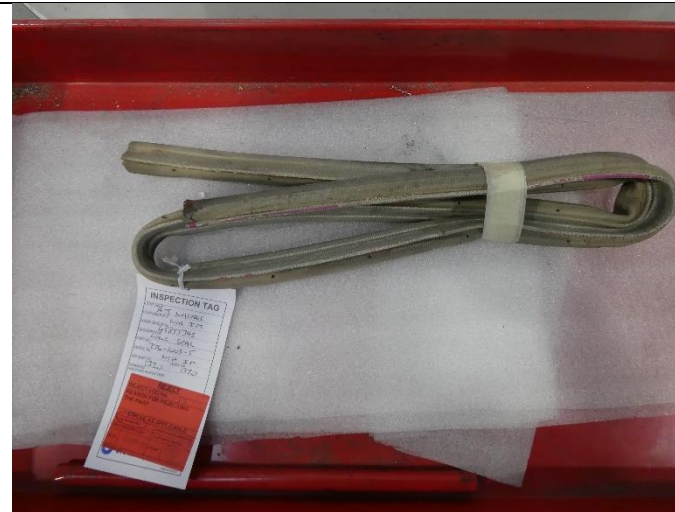
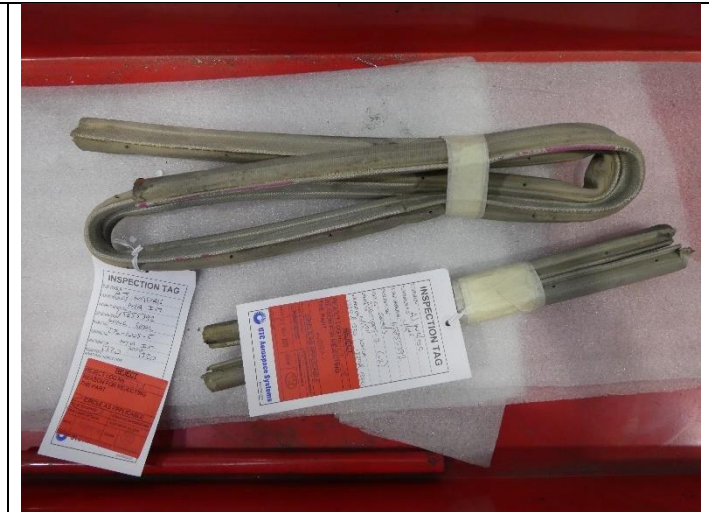
EXHIBIT No 10	EXHIBIT No 11	EXHIBIT No 12
<ul style="list-style-type: none"> Describe view: outer duct seals Extent of Damage: worn Dimensions of damage: across full part Operation relating to the IRR: 1320 For further details see Exhibit #: exhibit 11 Repair proposal: Replace seal i.a.w CMM 78-11-14 Repair 001. 	<ul style="list-style-type: none"> Describe view: outer duct seals Extent of Damage: worn Dimensions of damage: across full part Operation relating to the IRR: 1320 For further details see Exhibit #: exhibit 12 Repair proposal: Replace seal i.a.w CMM 78-11-14 Repair 001. 	<ul style="list-style-type: none"> Describe view: LH inner annulus seals Extent of Damage: worn Dimensions of damage: across full part Operation relating to the IRR: 1320 For further details see Exhibit #: n/a Repair proposal: Replace LH inner annulus seals i.a.w CMM 78-11-14 Repair 001.

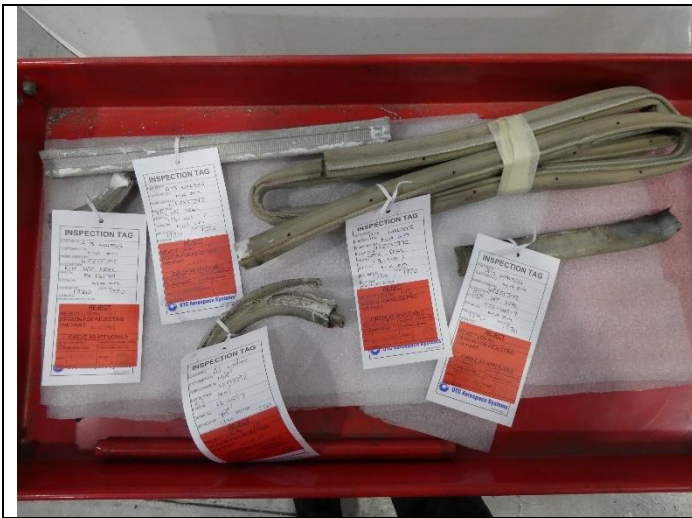
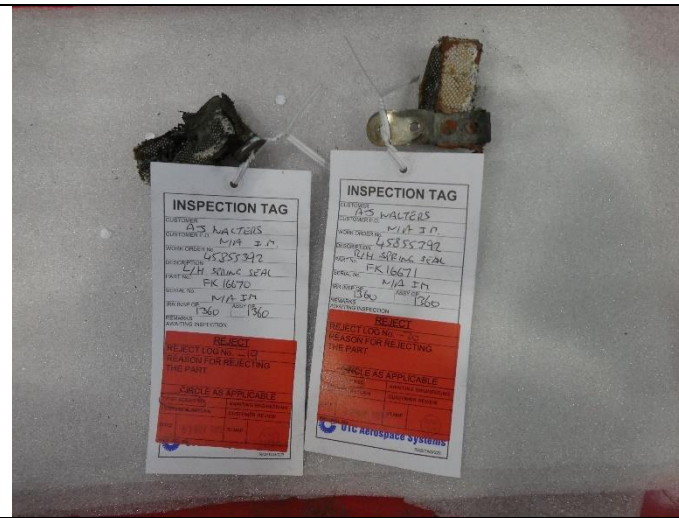
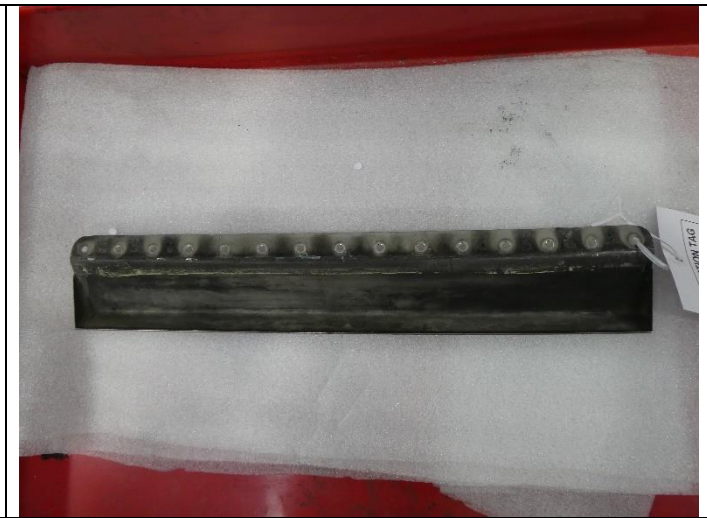
EXHIBIT No 13	EXHIBIT No 14	EXHIBIT No 15
<ul style="list-style-type: none"> Describe view: RH inner annulus seals Extent of Damage: worn Dimensions of damage: across full part Operation relating to the IRR: 1330 For further details see Exhibit #: n/a Repair proposal: Replace RH inner annulus seal i.a.w CMM 78-11-14 Repair 001. 	<ul style="list-style-type: none"> Describe view: LH/RH corner seal Extent of Damage: torn Dimensions of damage: 1.0" Operation relating to the IRR: 1360 For further details see Exhibit #: n/a Repair proposal: Replace LH and RH corner seals i.a.w. CMM 78-11-14 Repair 003. 	<ul style="list-style-type: none"> Describe view: Spring seal Extent of Damage: worn Dimensions of damage: across landing face Operation relating to the IRR: 1370 For further details see Exhibit #: n/a Repair proposal: Replace spring seal i.a.w CMM 78-11-14 Repair 003.

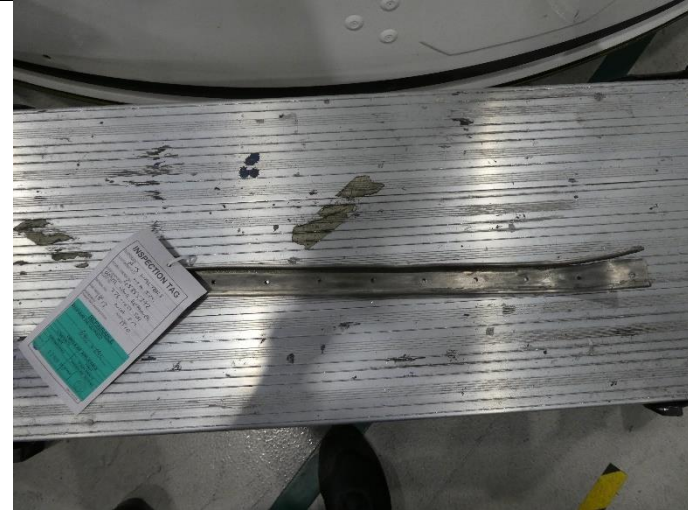
EXHIBIT No 16	EXHIBIT No 17	EXHIBIT No 18
<ul style="list-style-type: none"> • <u>Describe view:</u> LH upper retainer • <u>Extent of Damage:</u> cracked • <u>Dimensions of damage:</u> 3.0" • <u>Operation relating to the IRR:</u> 1513 • <u>For further details see Exhibit #:</u> n/a • <u>Repair proposal:</u> Repair i.a.w. Weld sheet data contained on pages 64B-64D of 121. (weld repair) 	<ul style="list-style-type: none"> • <u>Describe view:</u> n/a • <u>Extent of Damage:</u> n/a • <u>Dimensions of damage:</u> n/a • <u>Operation relating to the IRR:</u> n/a • <u>For further details see Exhibit #:</u> n/a • <u>Repair proposal:</u> n/a 	<ul style="list-style-type: none"> • <u>Describe view:</u> n/a • <u>Extent of Damage:</u> n/a • <u>Dimensions of damage:</u> n/a • <u>Operation relating to the IRR:</u> n/a • <u>For further details see Exhibit #:</u> n/a • <u>Repair proposal:</u> n/a
